NASA-CR 135303

FINAL REPORT

DEVELOPMENT OF SPIRAL-GROOVE SELF-ACTING FACE SEALS

**AVCO LYCOMING DIVISION
550 South Main Street
Stratford, Connecticut 06497**

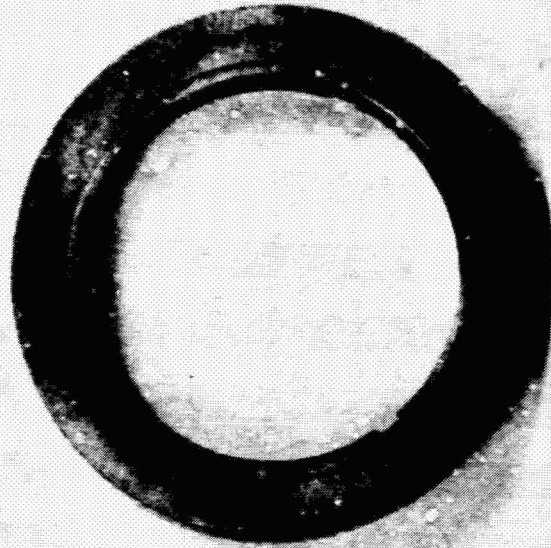
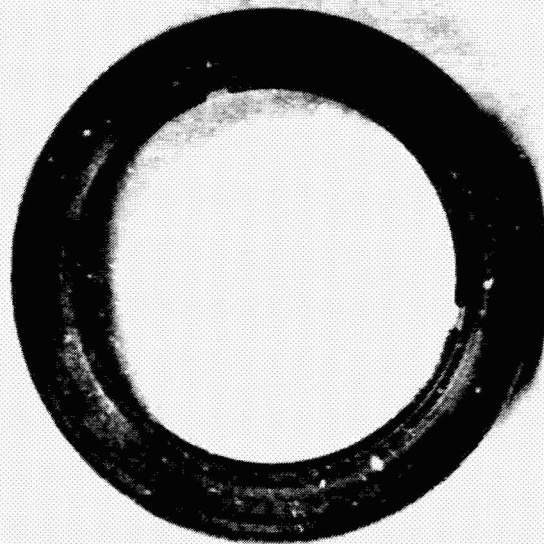
Figure 24 illustrates the forward and aft sealing elements after Build II testing. Figure 25 illustrated the back (normally nonsealing side) of seal seats with the forward seat illustrating contact marks from sealing element due to it being reversed. A wear ring on the aft seat, caused by unclamped operation can be seen. Figure 26 shows the opposite side (normally the sealing side) of the seats (contact side for aft seat). The forward sealing element, exhibiting heavy wear and shallow spiral-groove geometry, was replaced with a new part of Build III testing. Table IV illustrates changes in face dimensions after Build II testing.

Figure 25. Back of Seal Seats After Build Up Testing.

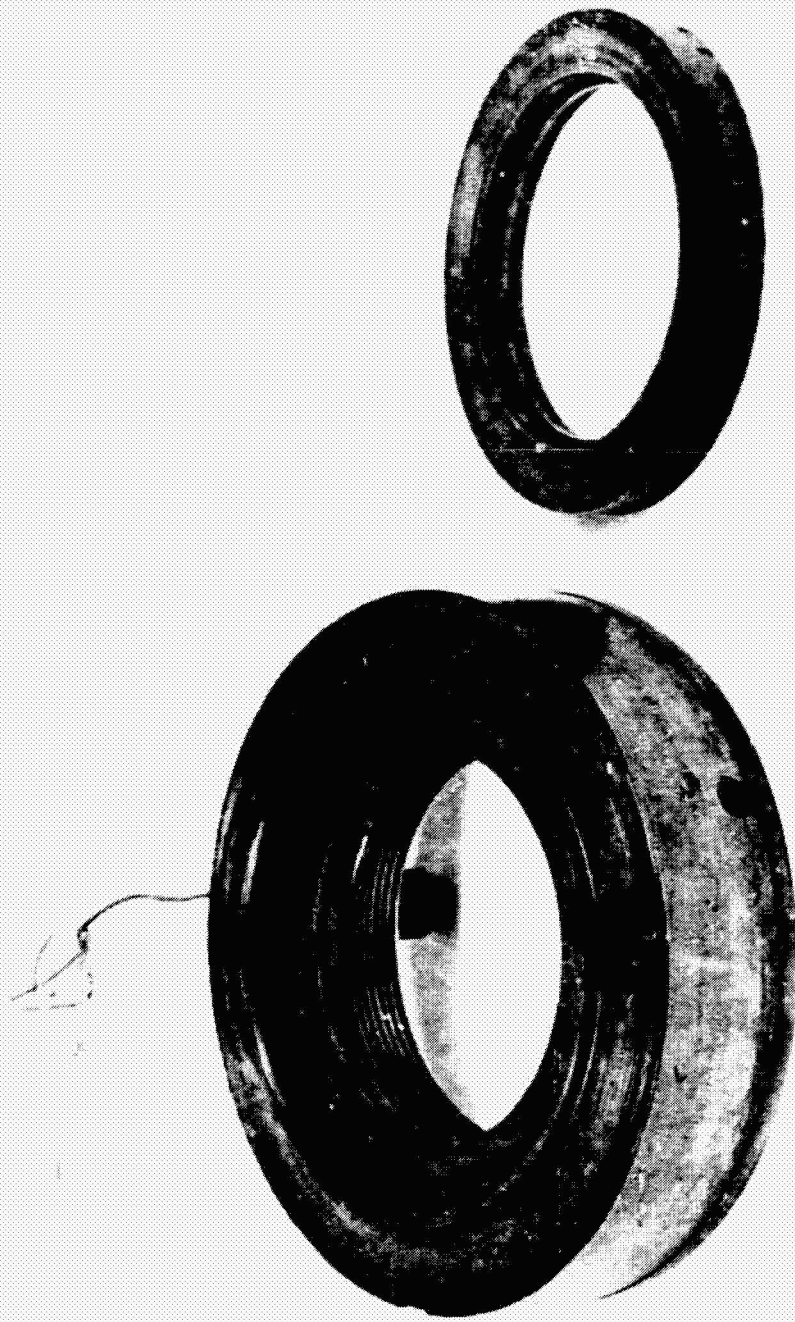
Figure 33. Forward Seal Assembly and Seat After Endurance Test, Build I.

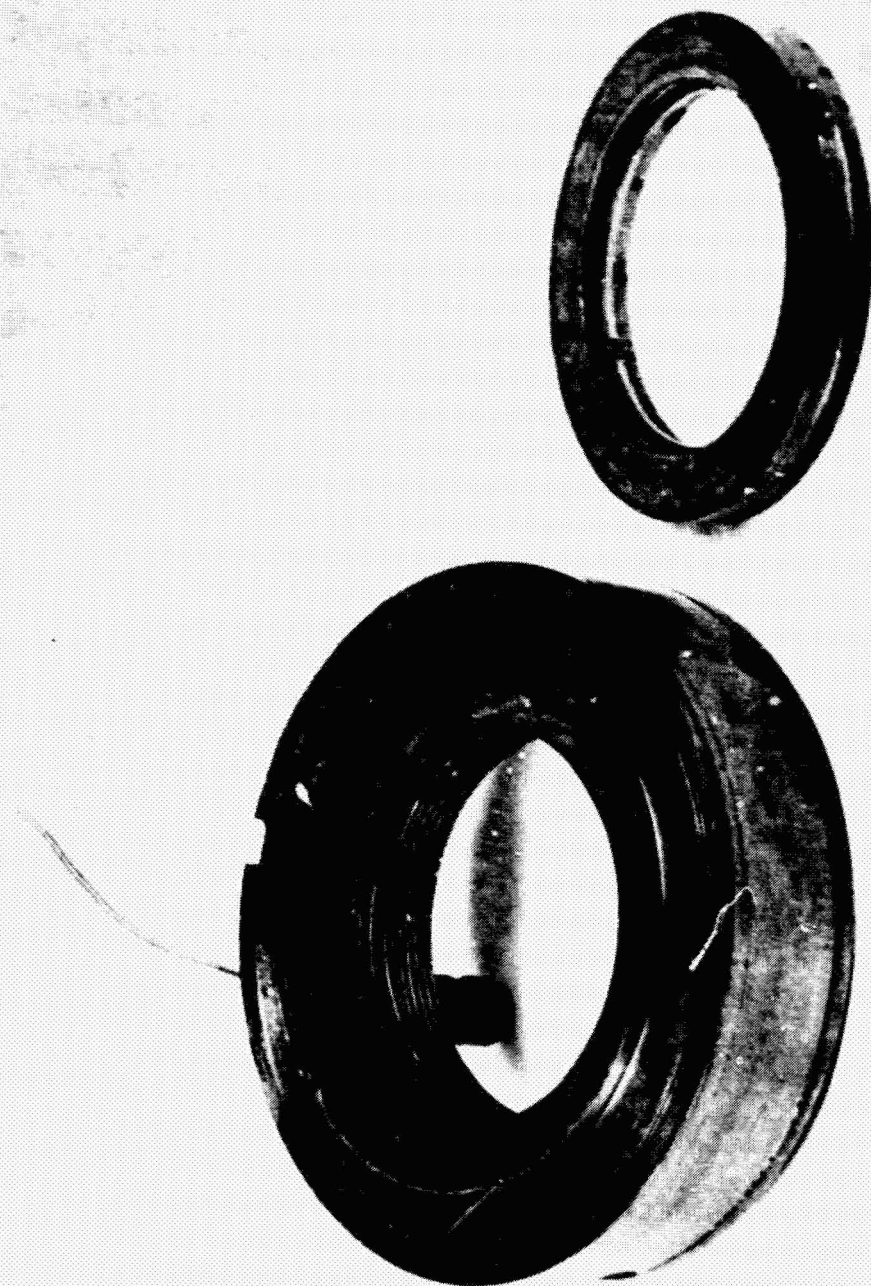
Figure 34. Aft Seal Assembly and Seat After Endurance Test, Build I.

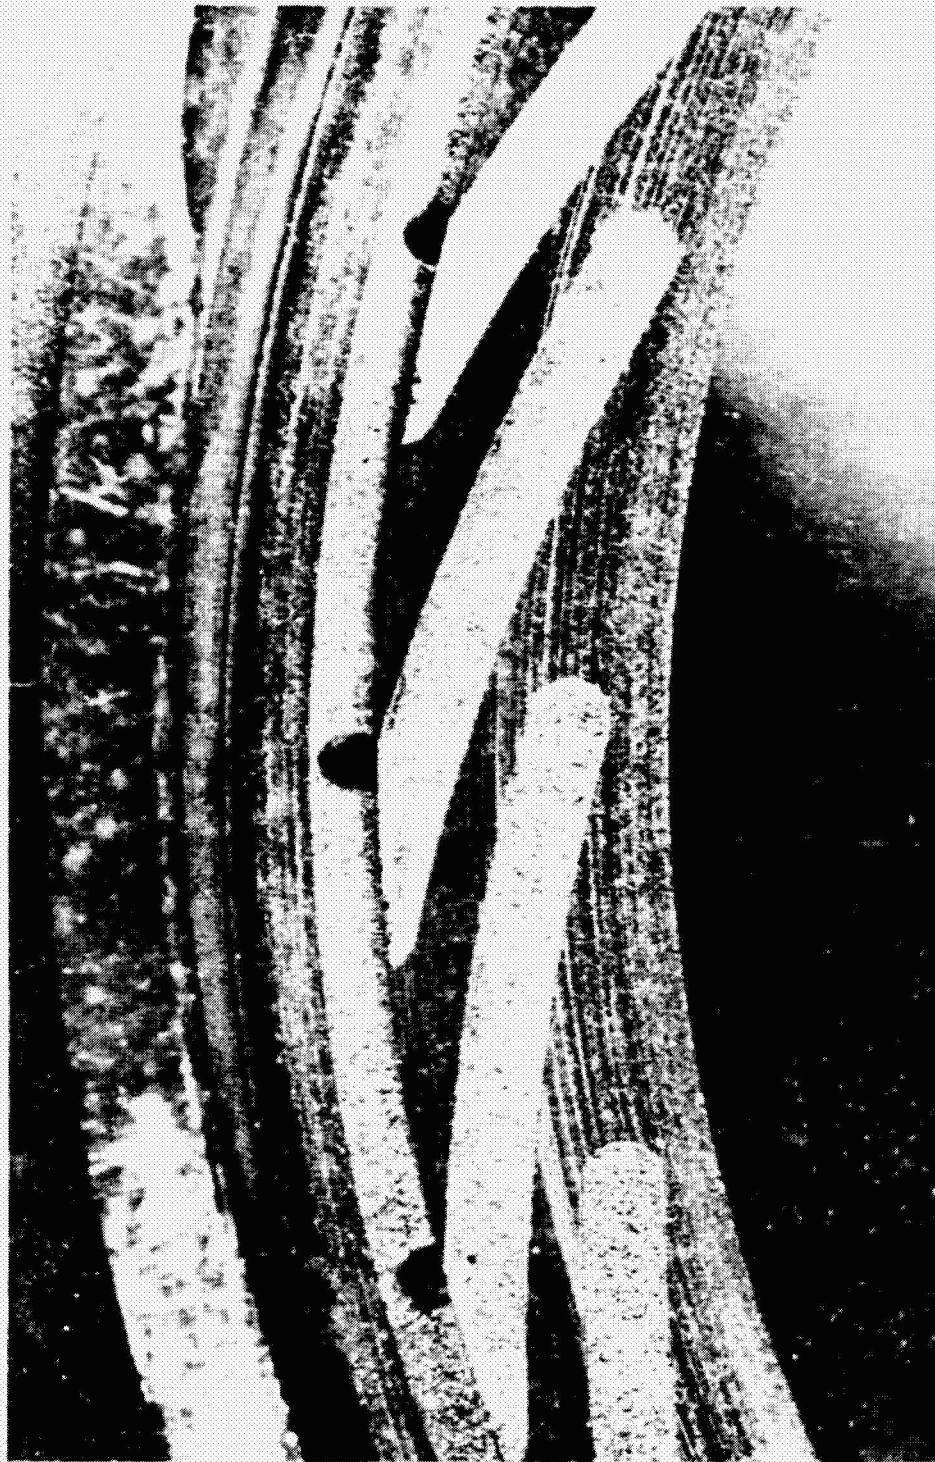
Figure 35. Forward Seal Spiral Groove Geometry After Endurance Test, Build I.

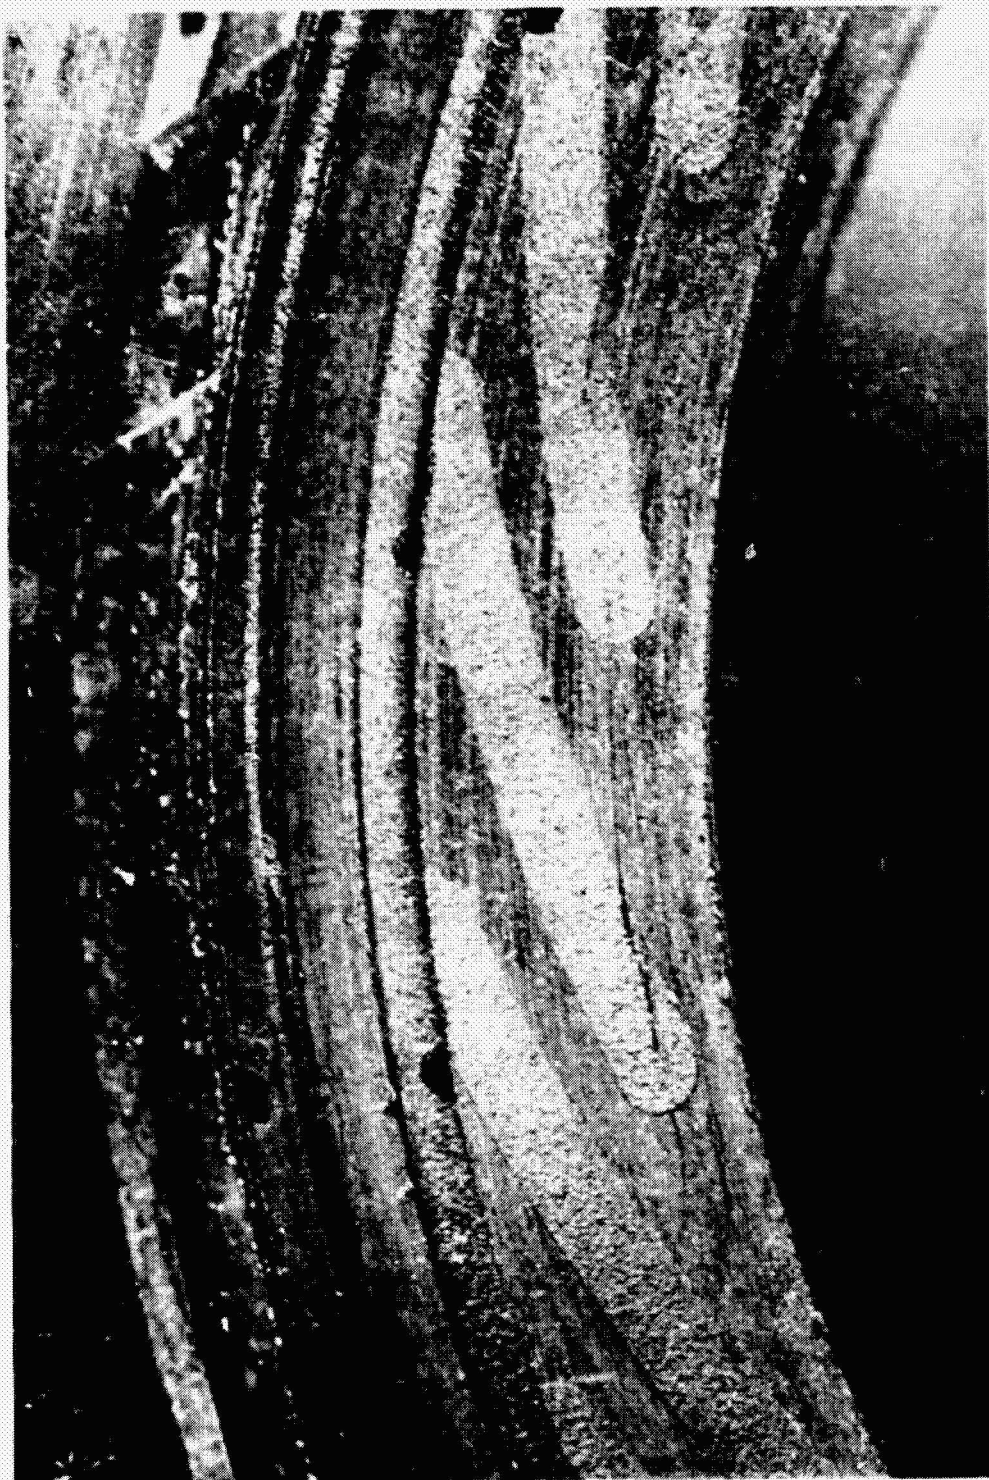
Figure 36. Aft Seal Spiral Geometry After Endurance Test
Build I.

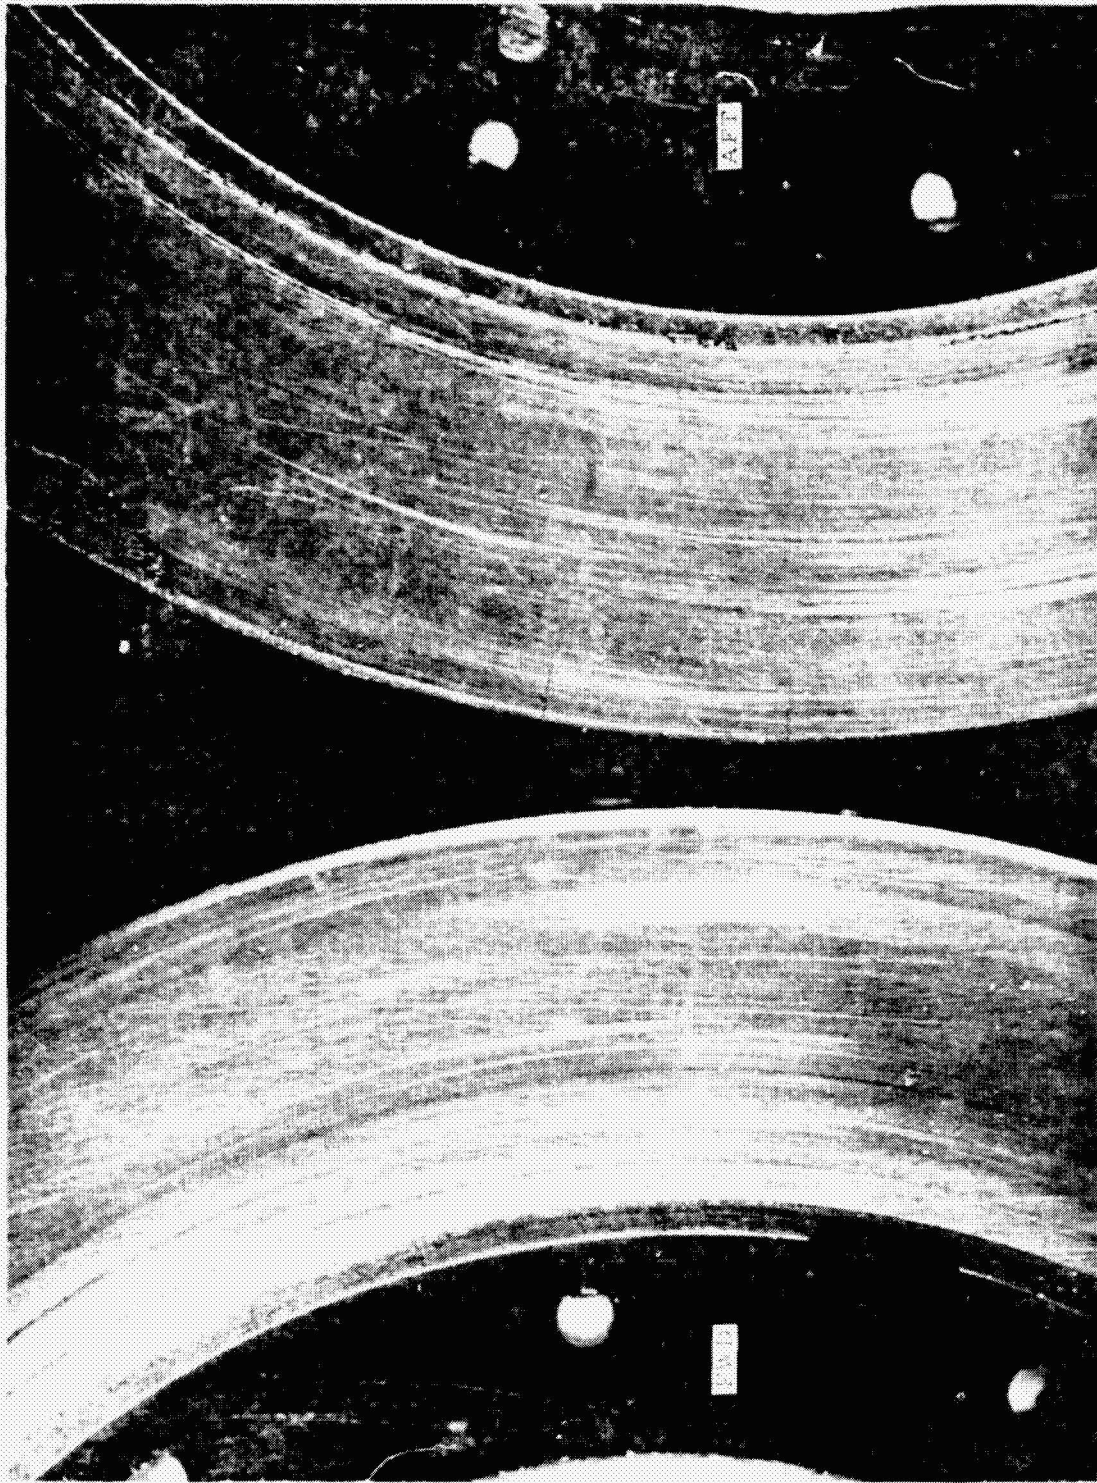
Figure 37. Forward and Aft Seal Seats After Endurance Test, Build I.

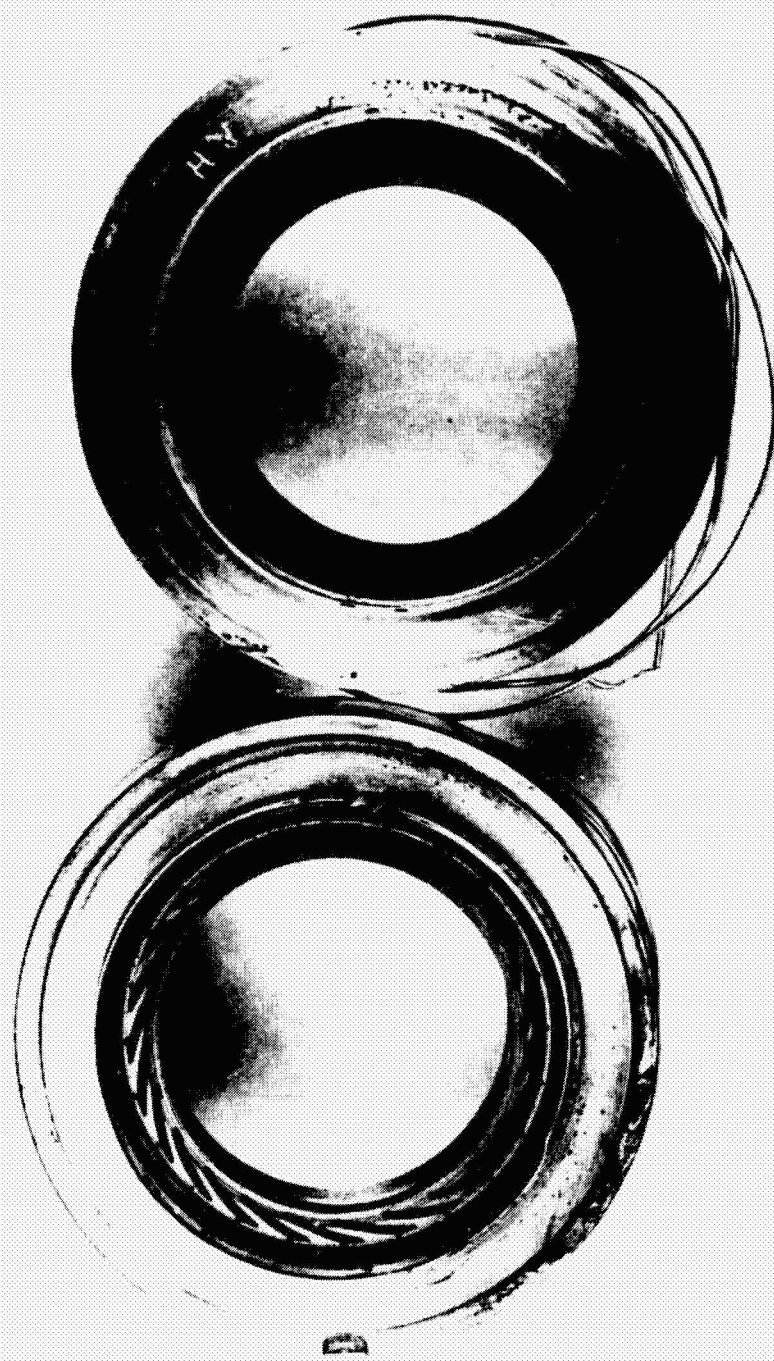
The test rig was rebuilt, and the endurance test was completed without problem. At the end of the endurance test, seal operation at 243 m/s (800 ft/sec) was accomplished. The condition of the seals at the completion of the endurance test is documented in Figures 39 through 52. Inspection revealed coking of the internal seal components had continued, and sufficient deposits had formed on the housing and piston ring carrier to prevent the seals from returning to their normal free height. Coke within the coil springs limited their action as did coke in the spring cavity (Figures 48 and 49). The effected forward seal components were less coked than the corresponding aft seal components. The piston rings of both seals were free from coke. (Figure 51)

Figure 39. Forward and Aft Seal Assemblies After Endurance Test, Build II.

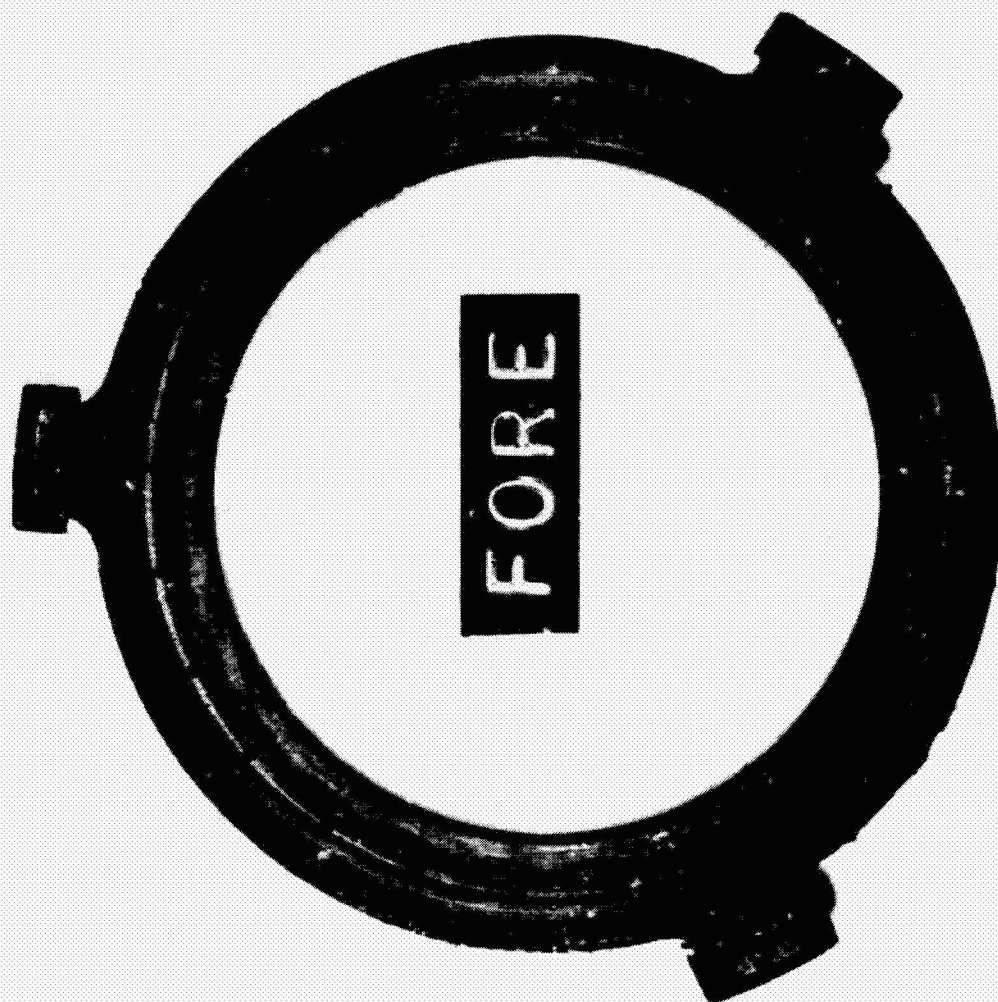
Figure 42. Forward Sealing Element After Endurance Test,
Build II.

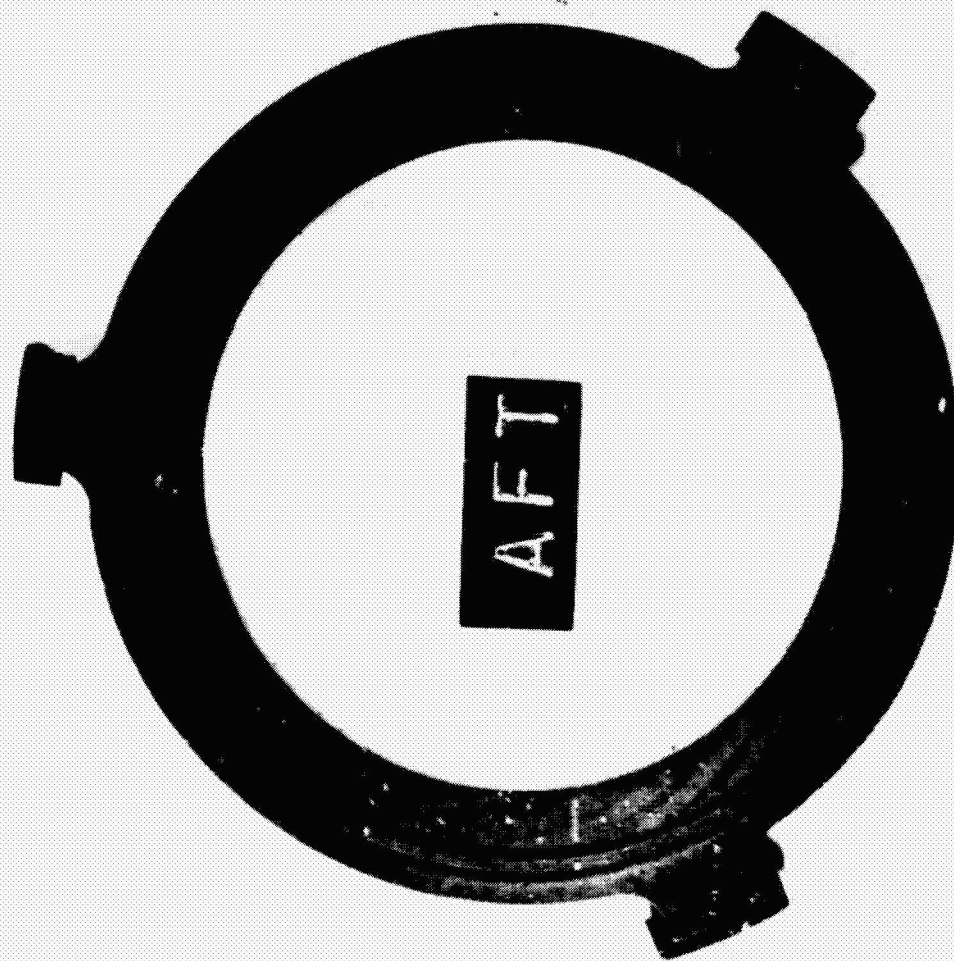
Figure 43. Aft Sealing Element After Endurance Test, Build II.

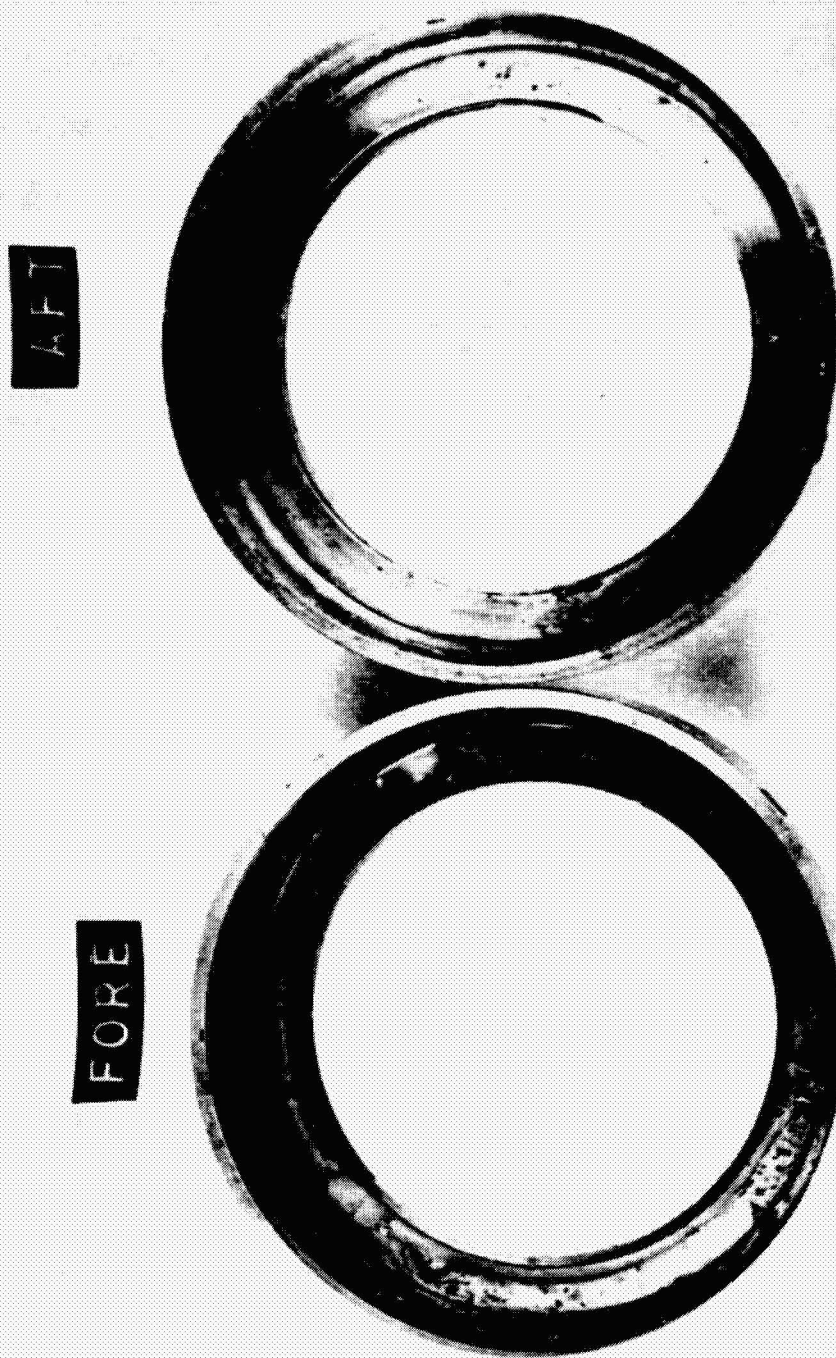
Figure 46. Interior of Housing Covers, Forward and Aft,
After Endurance Test, Build II.

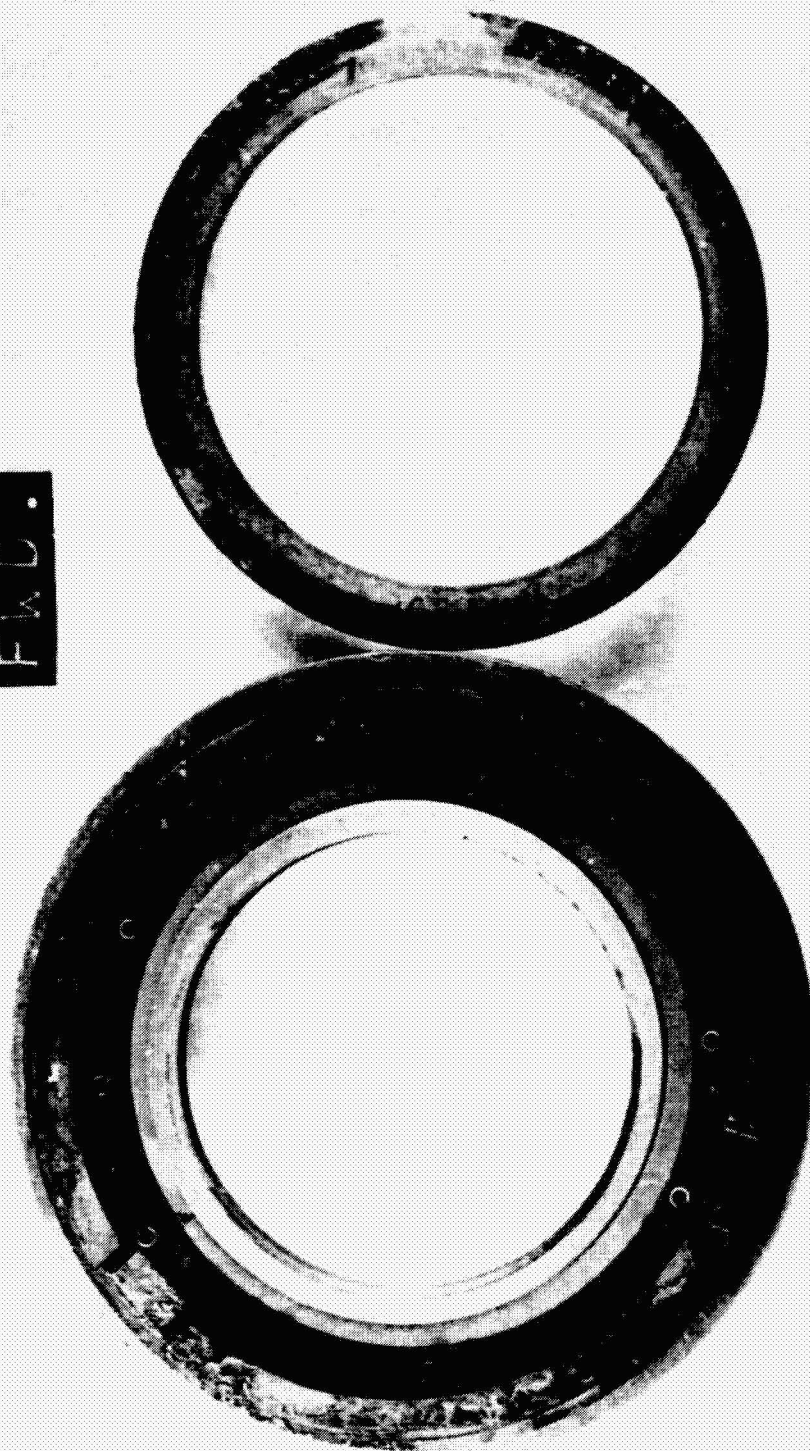
Figure 48. Forward Seal Housing and Piston Ring Carrier
After Endurance Test, Build II.

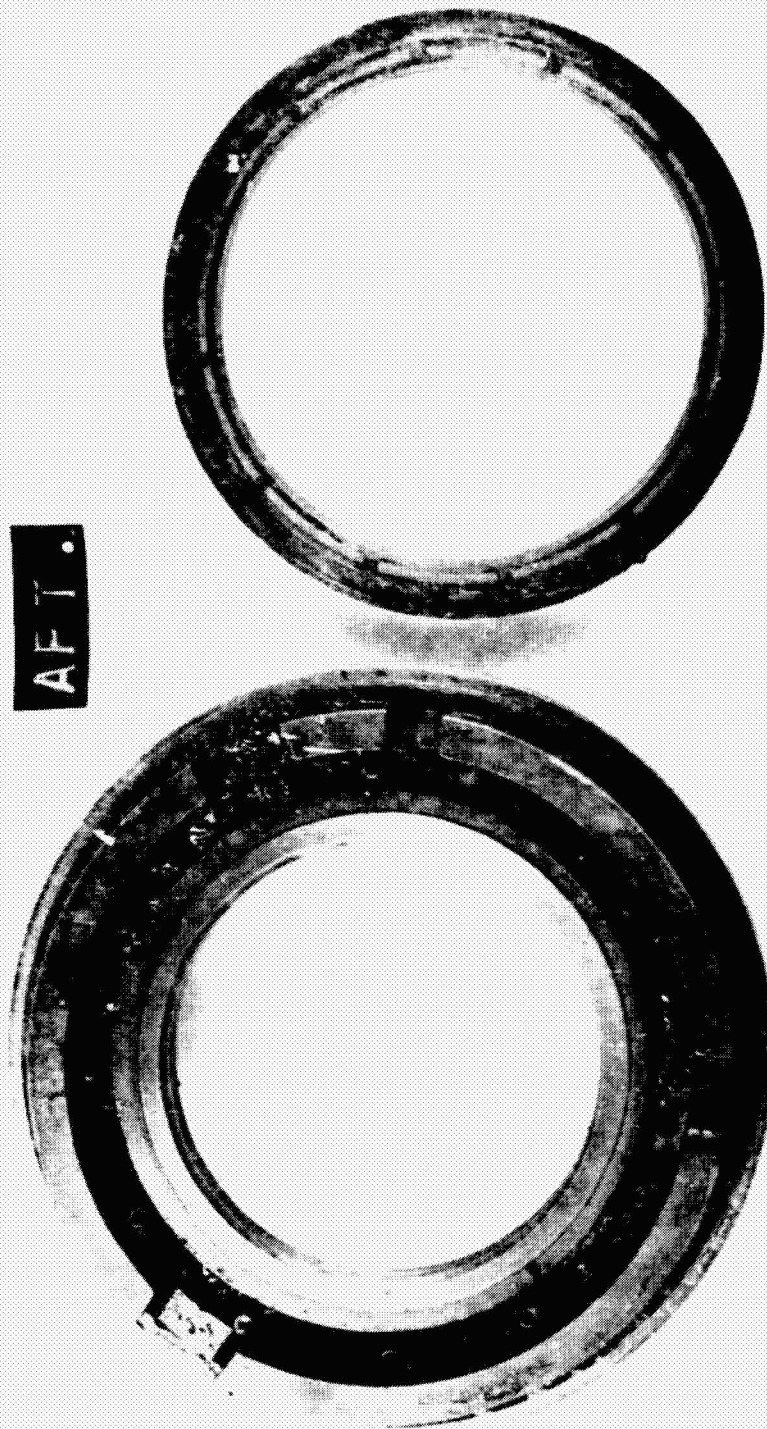
Figure 49. Aft Seal Housing and Piston Ring Carrier After
Endurance Test, Build II.

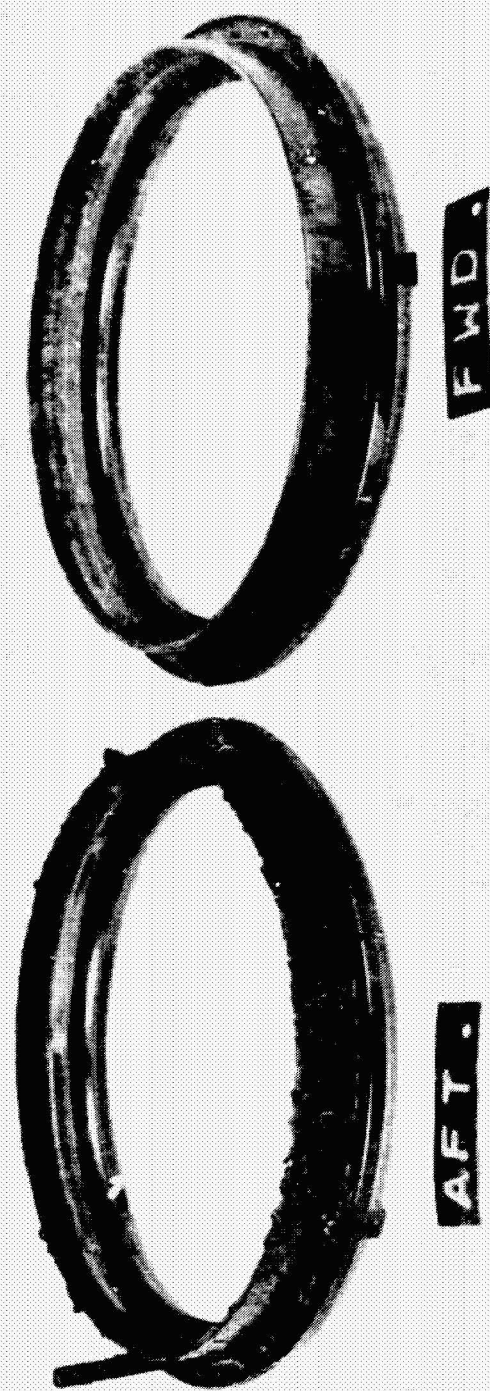
Figure 50. O. D. View of Forward and Aft Piston Ring Carriers After Endurance Test, Build II.

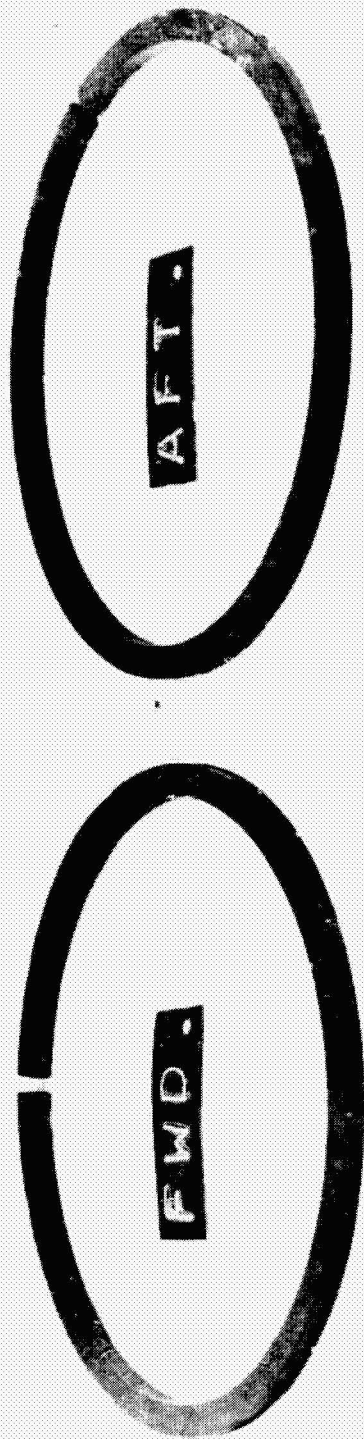
Figure 51. Forward and Aft Piston Rings After Endurance Test, Build II.

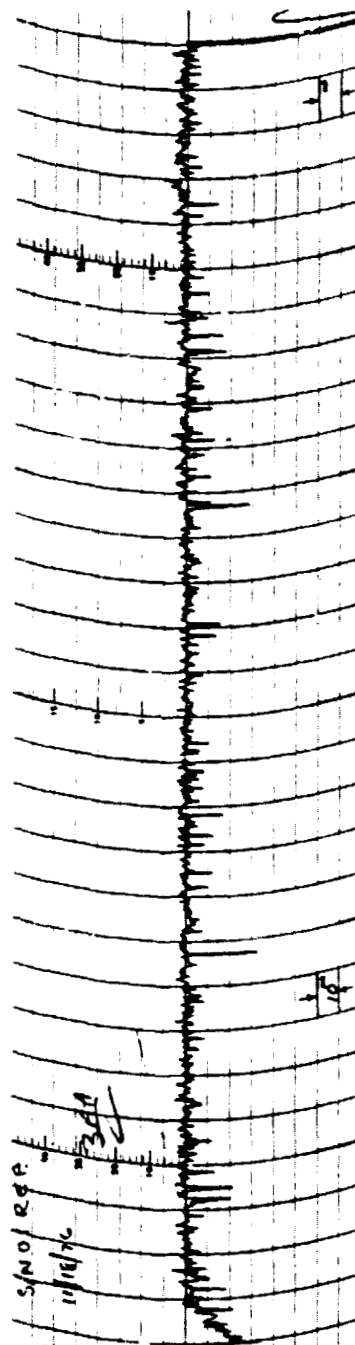
Fwd Seal Seat Finish Prior to Endurance Test

No After 'Test Traces Due To Damaged Parts
